FINAL REPORT OF SPECIFIC PURPOSE LIDAR SURVEY

LiDAR, Breaklines and Contours for Gulf County, Florida

State of Florida
Division of Emergency Management
Contract 07-HS-34-14-00-22-469
Task Order 20070525-492718a
PDS Task Order B

**Final Report of Specific Purpose LiDAR Survey, including
LiDAR-Generated Breaklines and Contours for Gulf County, Florida
Contract 07-HS-34-14-00-22-469; T.O. No. 20070525-492718a, Task Order B**

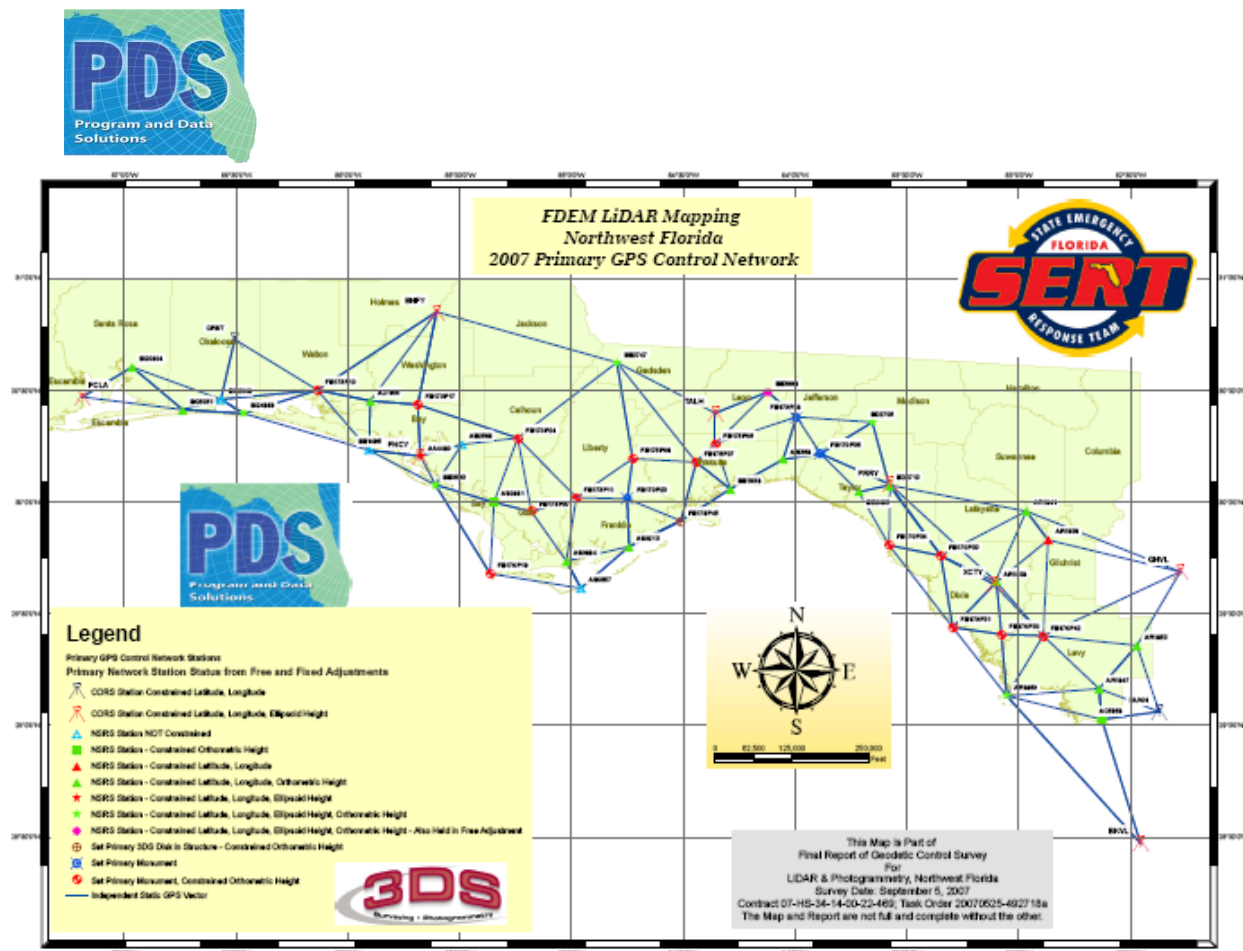
Figure 1. Primary Control Network

The Primary network stations (see Figure 1) were used as base stations supporting the airborne GPS data acquisition, and as a consistent control framework for the more densely spaced Secondary control networks, and all subsequent control surveying activity on the project. They were setup at 40 kilometer spacing per the 2 centimeter requirements for Primary Control stated in the NOS NGS-58. The Primary Control network consisted of 55 stations, including 10 Continuously Operating Reference Stations (CORS), 27 existing monuments from the National Spatial Reference System (NSRS) and 18 new monuments set so as to limit LiDAR GPS baseline lengths to 20 Km relative to GPS base stations on either side of stations spaced ≈ 40 Km apart. Third order differential leveling was used to establish elevations on 20 Primary network stations in specific areas where published vertical stations could not be occupied directly with GPS. A minimally constrained (free) Least Squares adjustment was run to verify the internal accuracy of the Primary network. After evaluating and removing any outliers, a final free adjustment was generated, consisting of 191 independent vectors. The input error estimates were scaled by a factor of 14.90 which resulted in a properly weighted adjustment with a variance factor of 1.0154, with no flagged residuals. A constrained (fixed) 3-D horizontal adjustment was run using the same input error estimates as were used in the free adjustment; the variance factor was 1.3712 and there were no flagged residuals. A constrained (fixed) 1-D vertical adjustment was run using the same input error estimates as were used in the free adjustment; Station BE3991 was fixed in latitude, longitude and orthometric height; the variance factor was 1.2866 and there were no flagged residuals.

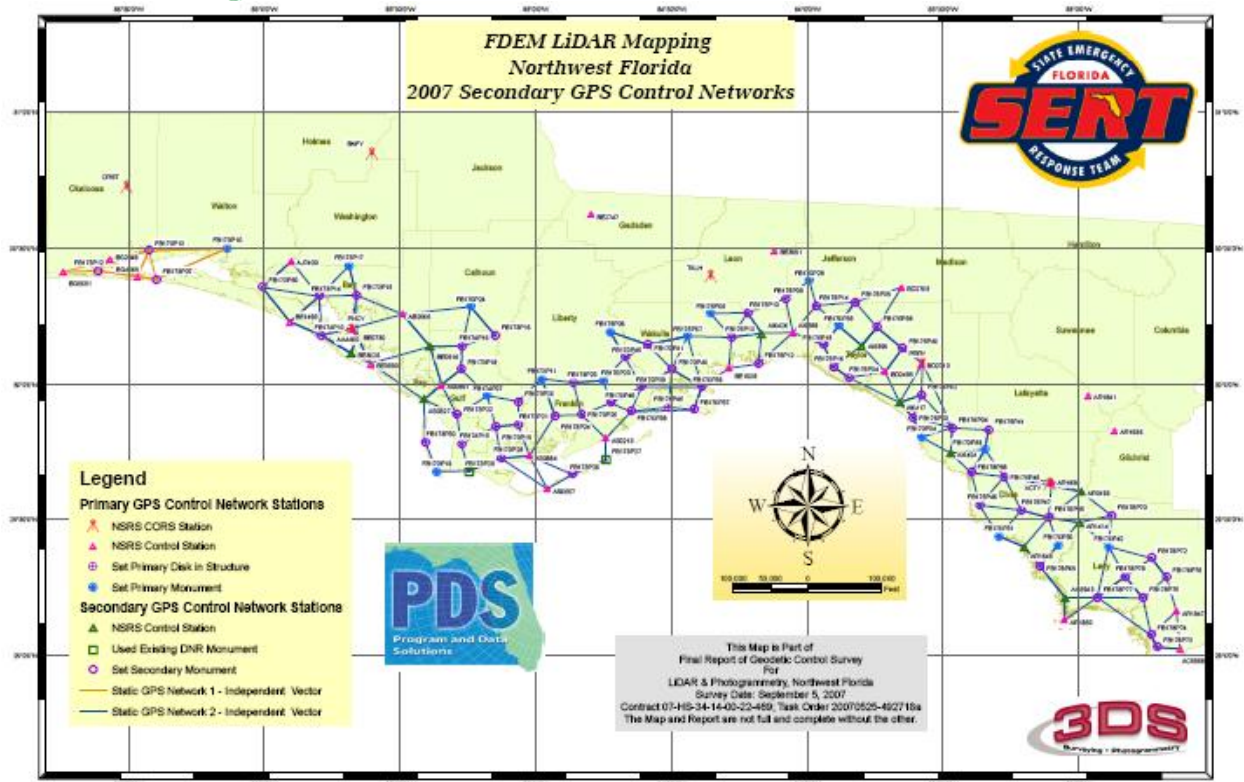
Figure 2. Secondary Control Networks

The first Secondary Control network consisted of 4 stations in the Okaloosa County area. The second Secondary Control network consisted of all remaining mapping areas in the Florida Panhandle. The Secondary Control networks included a total of 80 control points, including 16 recovered NSRS monuments, 2 recovered DNR monuments, and 62 new monuments set for this network. A minimally constrained (free) Least Squares adjustment was run to verify the internal accuracy of the Secondary networks. After evaluating and removing any outliers, a final free adjustment was generated. This final free adjustment consisted of 254 independent vectors. The input error estimates were scaled by a factor of 6.234, which resulted in a properly weighted adjustment with a variance factor of 1.000; there were no flagged residuals. A constrained (fixed) 3-D horizontal adjustment was run using the same input error estimates as were used in the free adjustment; the variance factor was 1.6339 and there were six flagged residuals. A constrained (fixed) 1-D vertical adjustment was run using the same input error estimates as were used in the free adjustment; Station BE3991 was fixed in latitude, longitude and orthometric height; the variance factor was 1.2136 and there were no flagged residuals.

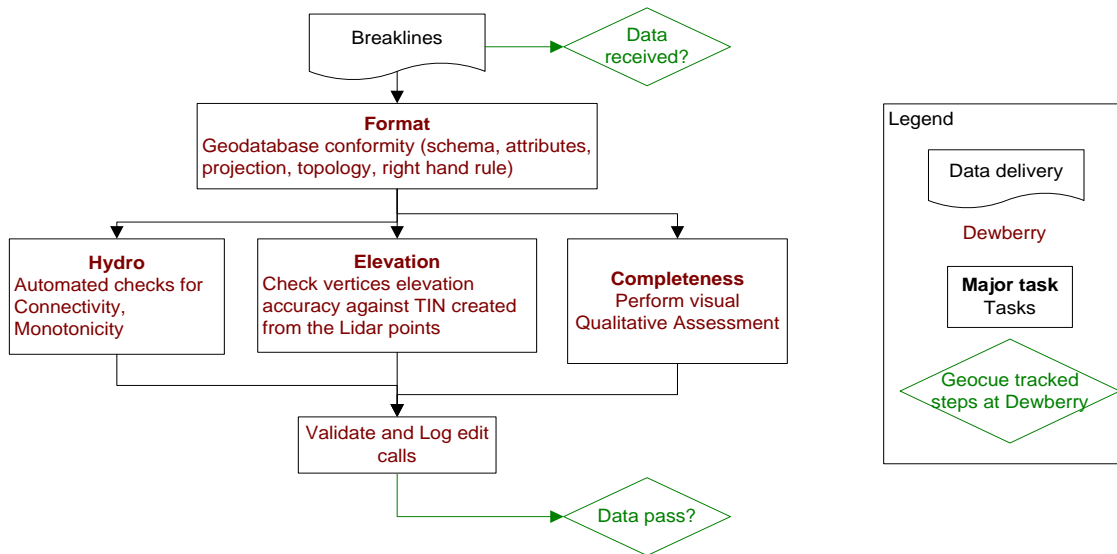
Dewberry performed the breakline qualitative assessments. The following workflow diagram represents the steps taken by Dewberry to provide a thorough qualitative assessment of the breakline data.

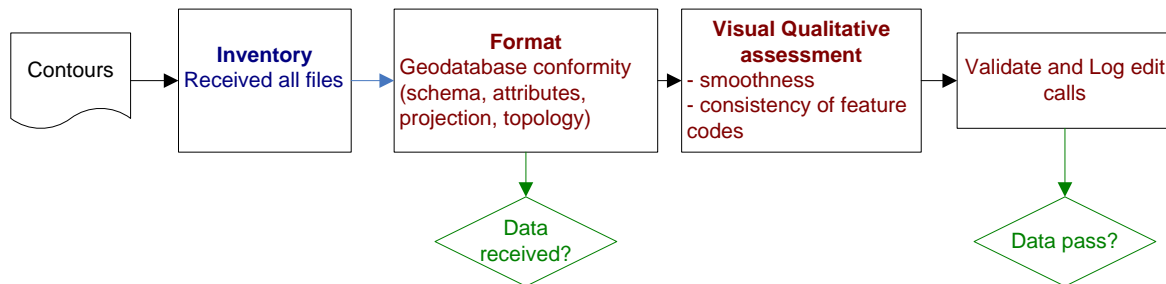
Dewberry also performed the qualitative assessments of the contours using the following workflow.

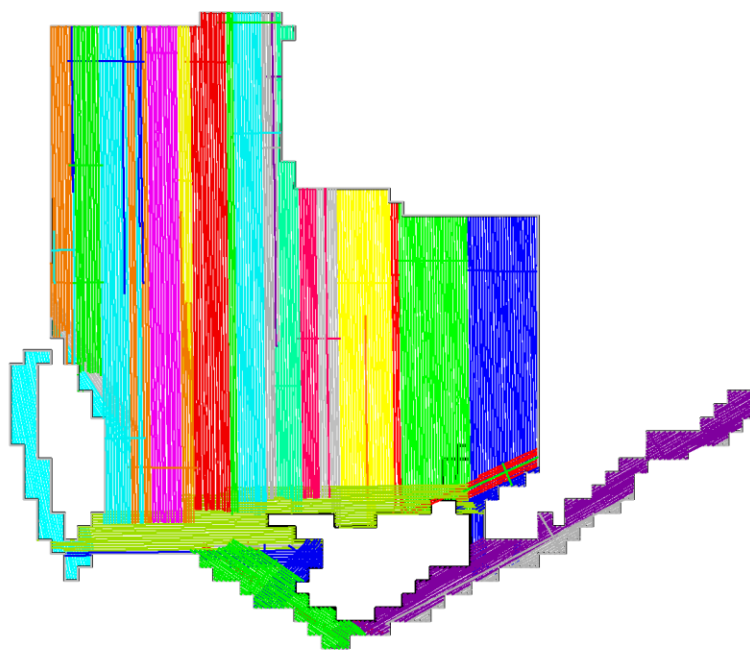
070907A
071207A
071307A
071407A
071507A
071507B
071607A
071607B
071607C
071707A
071707B
071807A
071807B
071807C
071907A
071907B
072007A
072007B
072107A
072107B
072207A
072207B

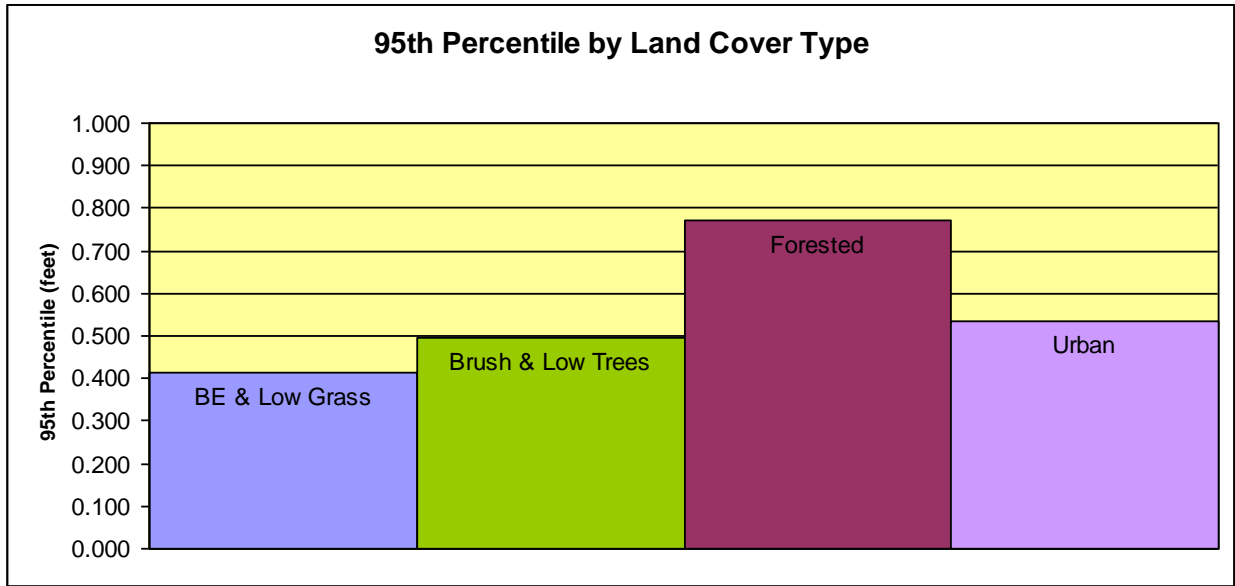
Figure 2 illustrates the SVA by specific land cover category.

Figure 2 — Graph of SVA Values by Land Cover

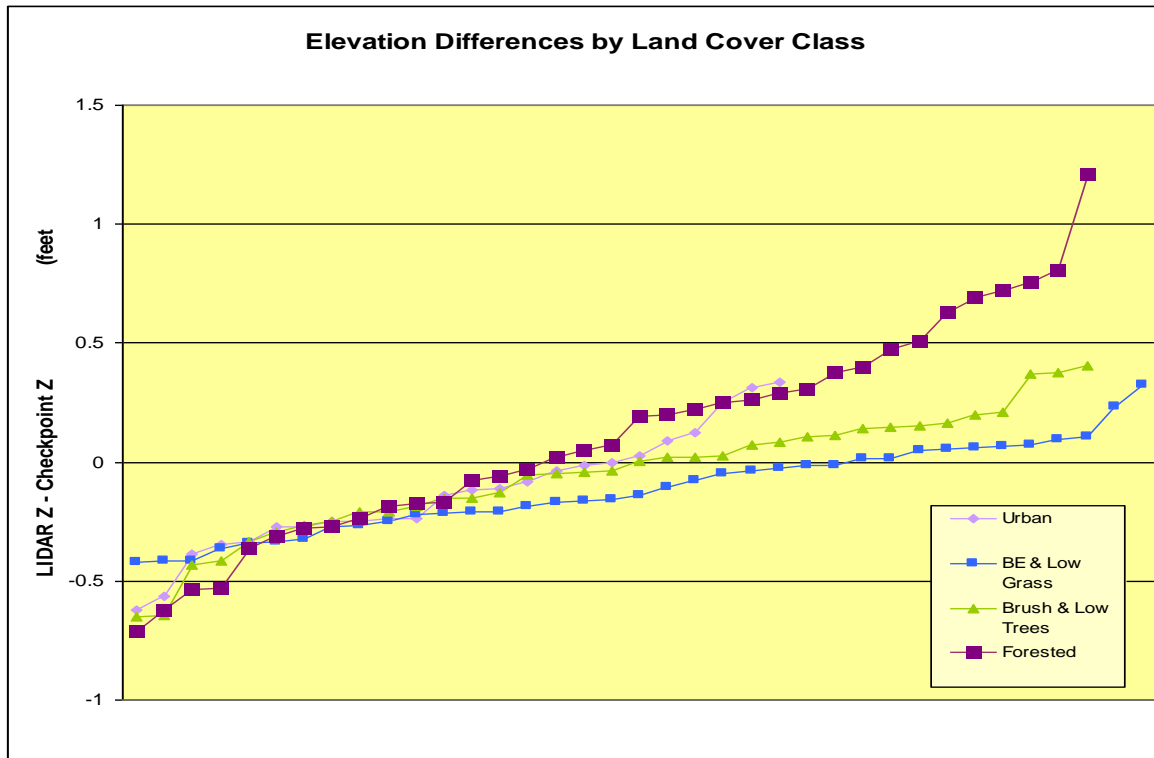
Figure 3 illustrates the magnitude of the differences between the QA/QC checkpoints and LiDAR data by specific land cover category and sorted from lowest to highest. This shows a normal distribution of points in the bare-earth and low grass category. Only one outlier point, in the forested land cover category, exceeded the 1.19 ft SVA accuracy criteria.

Figure 3 – Magnitude of Elevation Discrepancies, Sorted from Largest Negative to Largest Positive

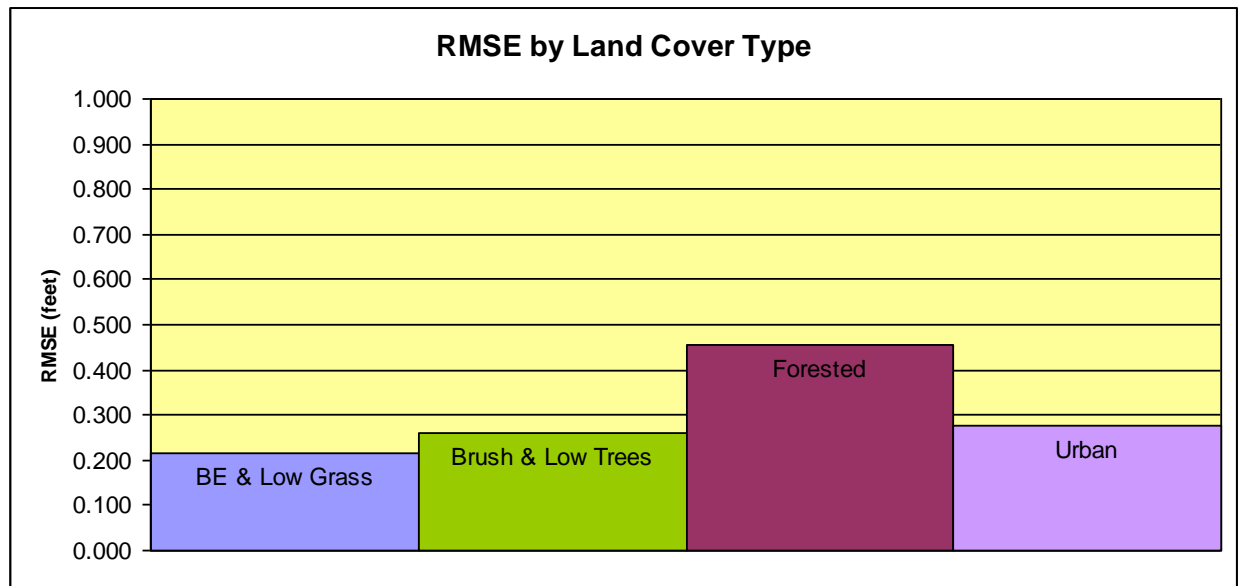
The NSSDA and FEMA guidelines were both published before it was recognized that LiDAR errors do not always follow a normal error distribution. Future changes to these FGDC and FEMA documents are expected to follow the lead of the NDEP and ASPRS. Nevertheless, to comply with FEMA's current guidelines in Reference C, $RMSE_z$ statistics were computed in all four land cover categories, individually and combined, as well as other statistics that FEMA recommends to help identify any unusual characteristics in the LiDAR data. These statistics are summarized in Figures 4 and 5 and Table 4 below, consistent with Section A.8.6.3 of Reference C.

Figure 4 — $RMSE_z$ statistics by Land Cover Category

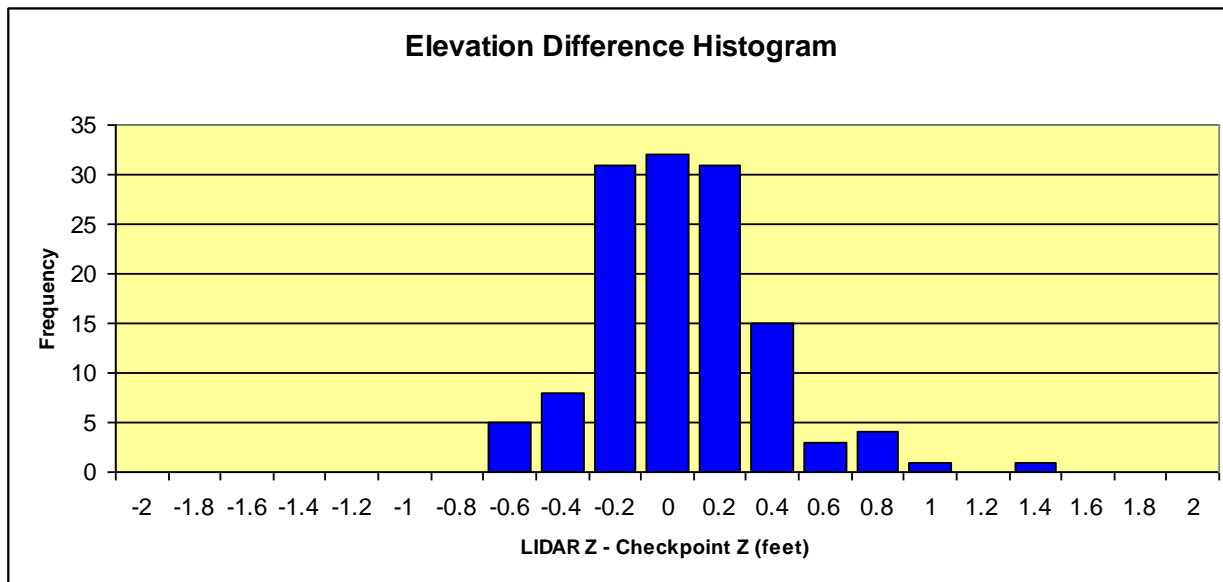
Figure 5 illustrates a histogram of the associated elevation discrepancies between the QA/QC checkpoints and elevations interpolated from the LiDAR triangulated irregular network (TIN). The frequency shows the number of discrepancies within each band of elevation differences. Although the discrepancies vary between a low of -0.72 ft and a high of +1.21 ft, the histogram shows that slightly more of the discrepancies are skewed on the positive side of what would be a “bell curve,” with mean of zero, if the data were truly normally distributed. Typically the discrepancies tend to skew a bit more to the positive side, because discrepancies in vegetation are typically positive.

Figure 5 — Histogram of Elevation Discrepancies within 0.20 ft Bands

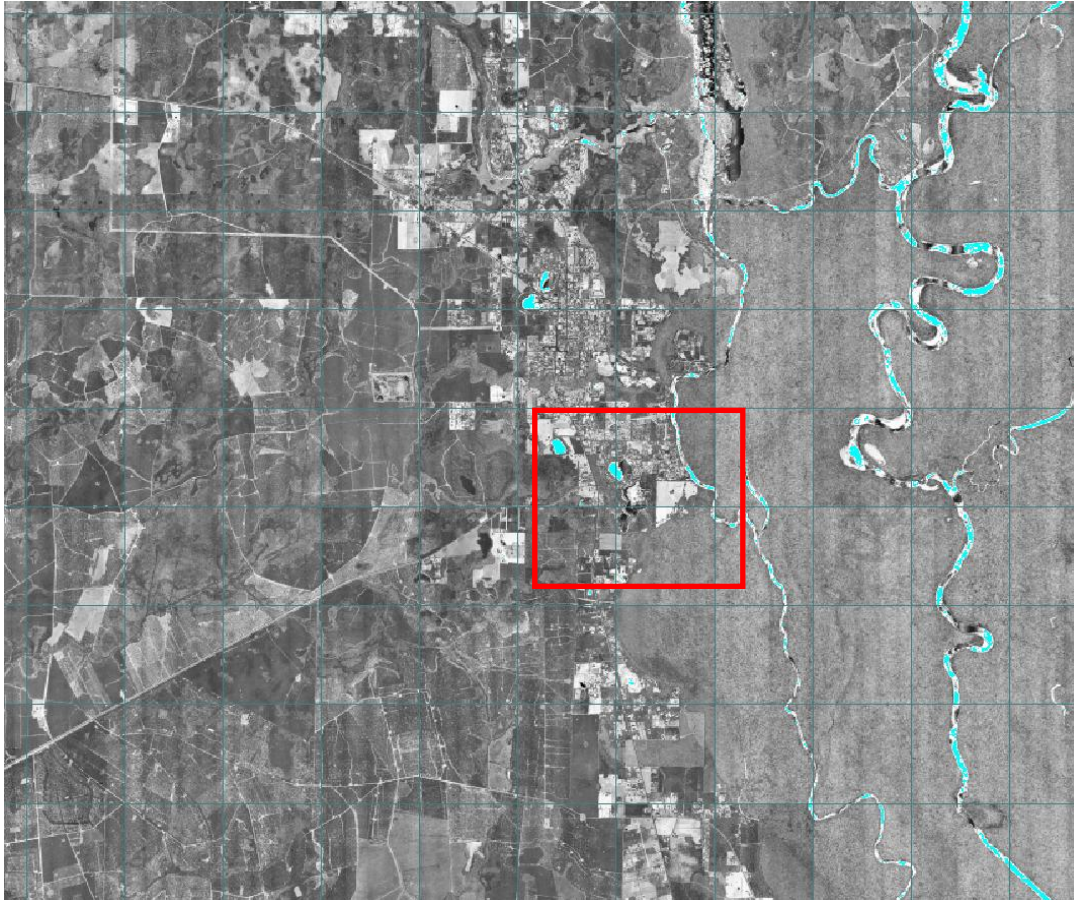
Figure 4: Lidar Ortho sample from Gulf County. Areas in Blue are acceptable. Data voids are caused by ponds, streams or water bodies.

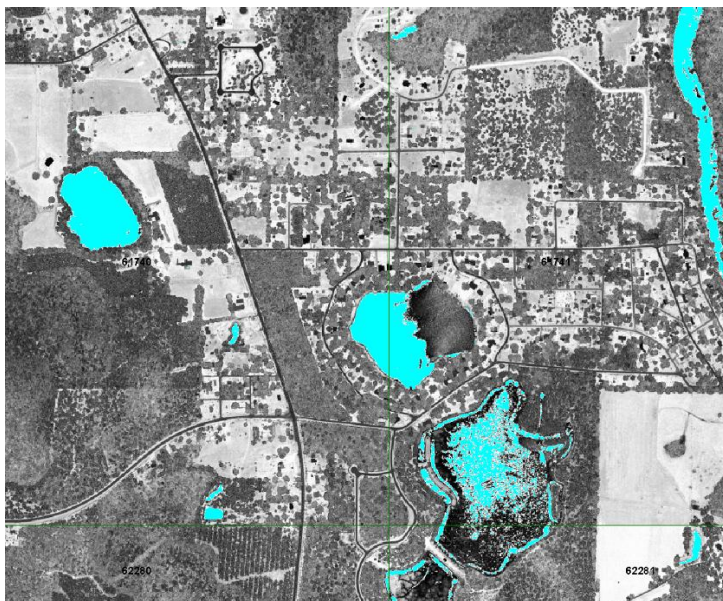
Figure 5: Tiles LID_061740-061741. Zoom showing water bodies

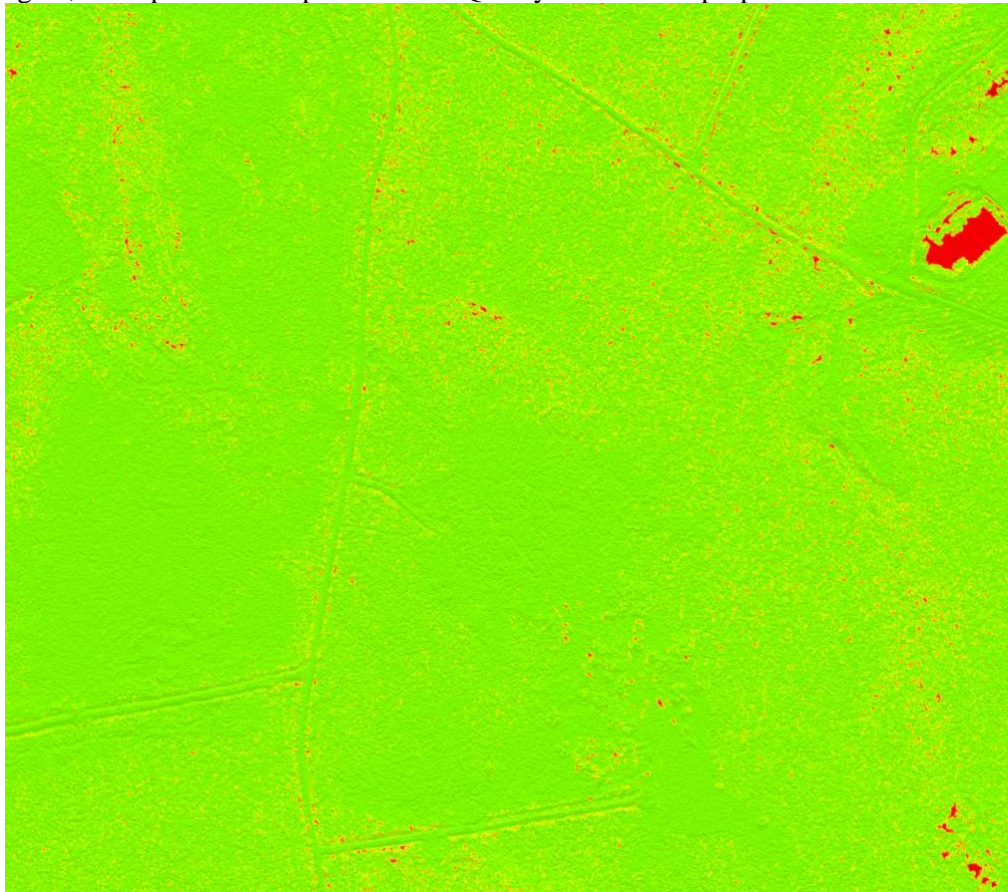
Figure 6: Sample density grid. Zoom of area with dense vegetation. Density grids were created at a 4 foot cell size using a green to red color ramp. Green areas indicate that the grid meets the 4 foot specification. Yellow to Red indicates that the 4 foot specification is not met.

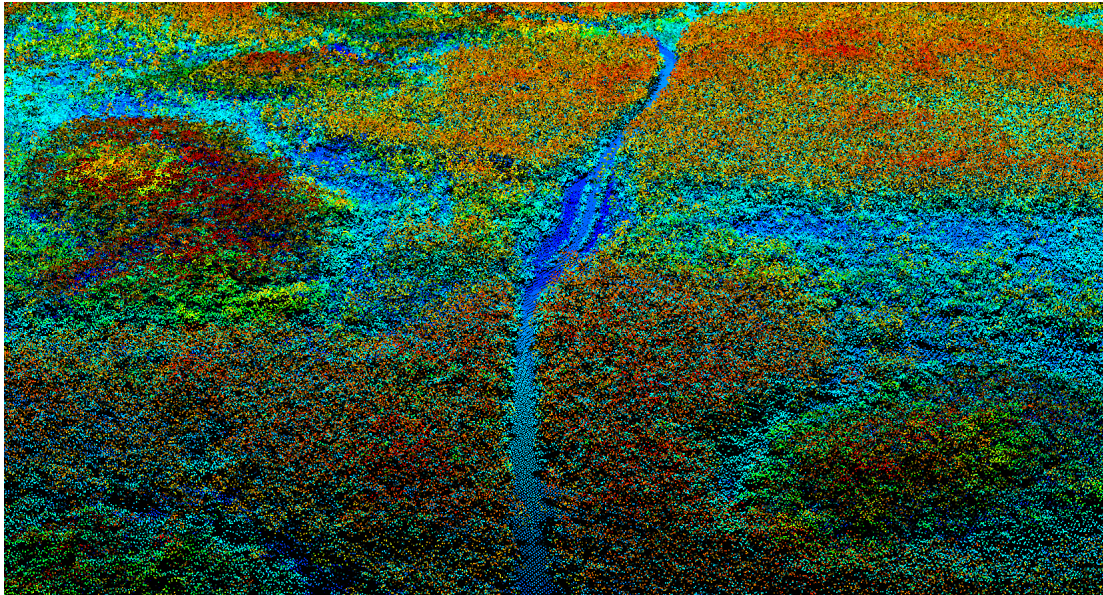
Figure 8: Tile 060117 example of heavy vegetation in Gulf County, Florida

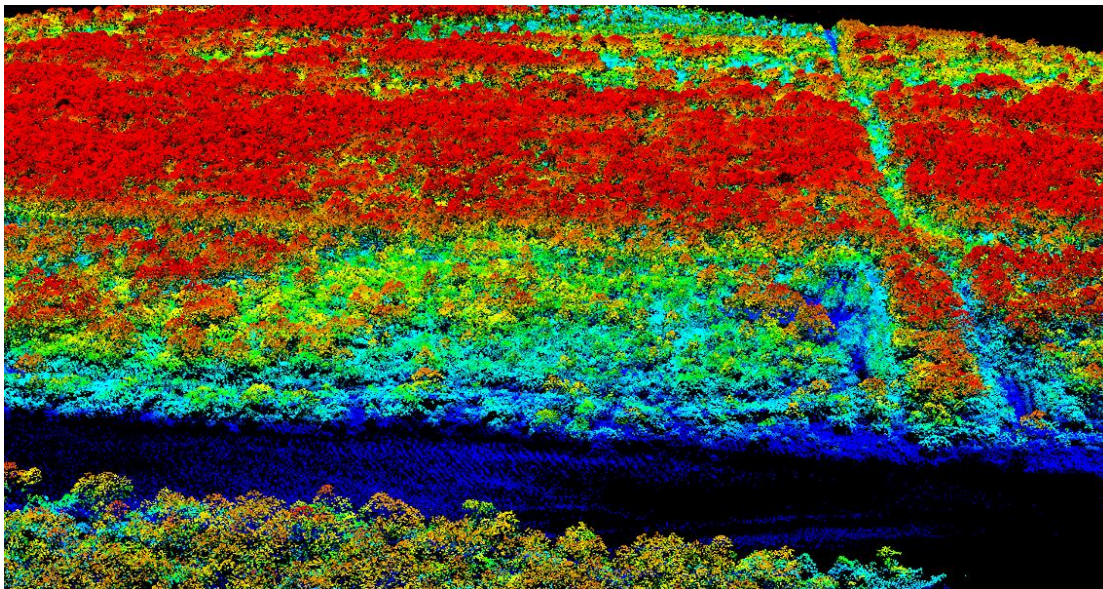
Figure 9: Tile 070914 example of vegetation along stream channel in Gulf County, Florida

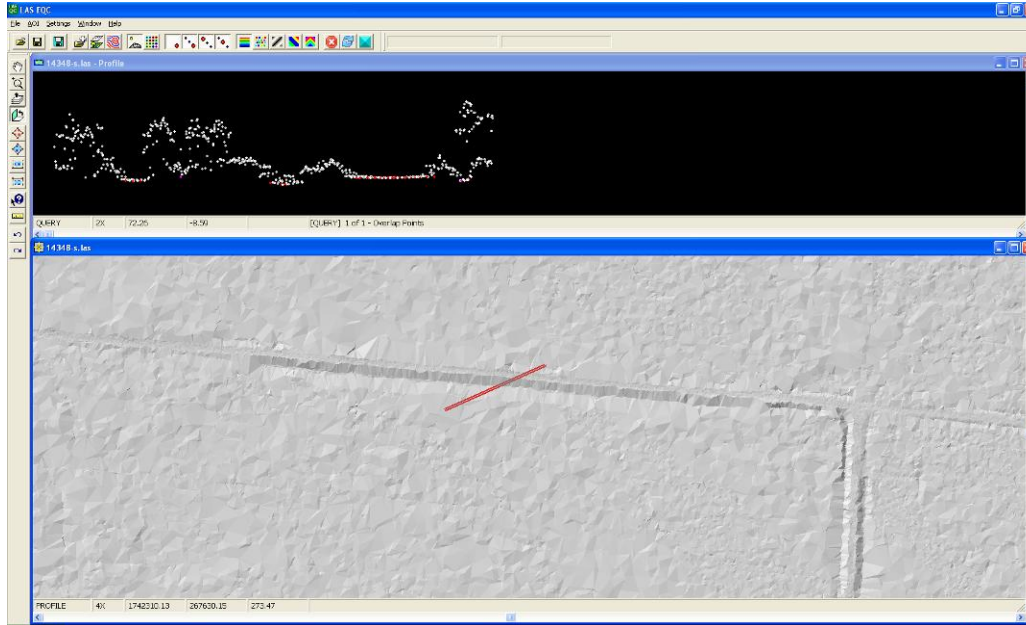
Figure 10: Tile 075779 example of vegetation at road edge. Dense vegetation growth at road edge did not allow much ground point penetration, breaklines are necessary to define road edges for contour generation.

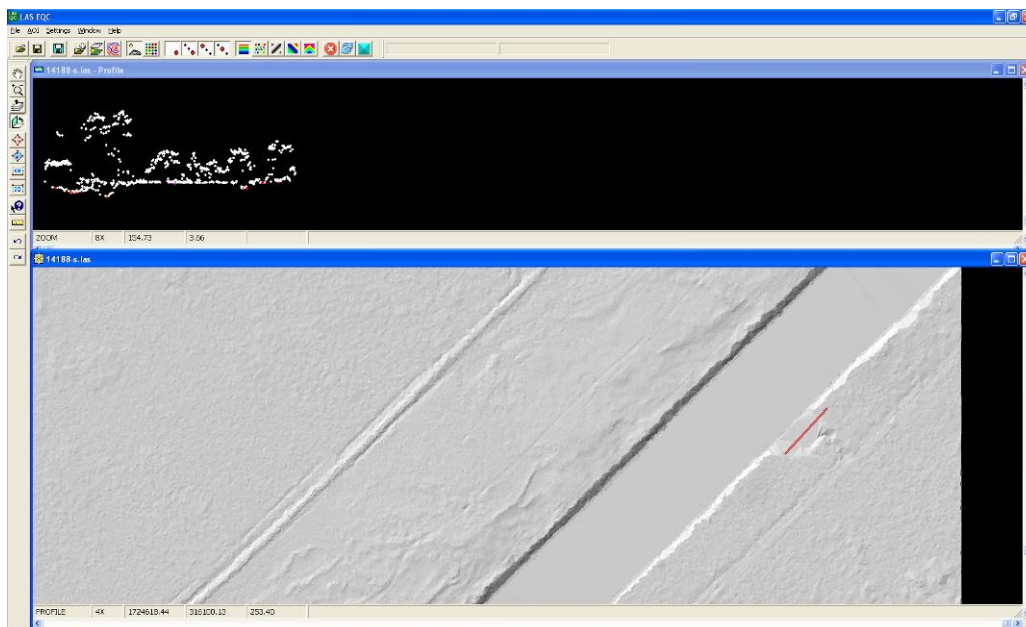
Figure 11: Tile 07375 example of high vegetation at stream channel edge. Dense vegetation at stream channels caused some areas to be “over-smoothed”. Breakline collection is necessary to clearly define stream channels.

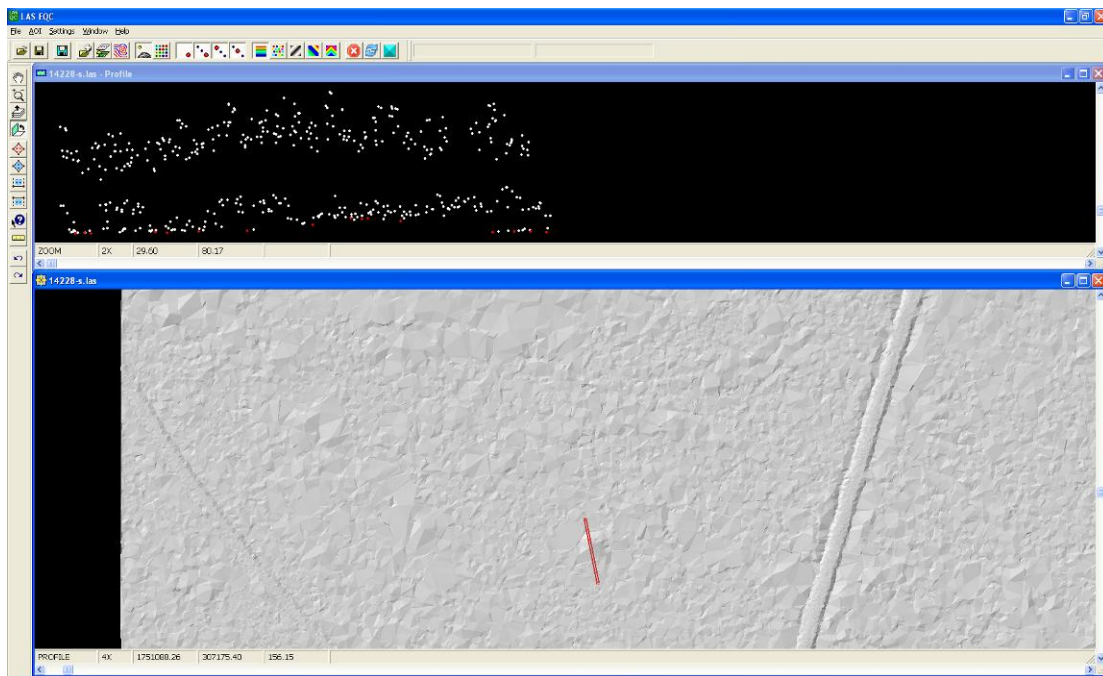
Figure 12: Tile 071461 example of dense high vegetation and understory causing issues with ground penetration. These areas are defined as low confidence areas.

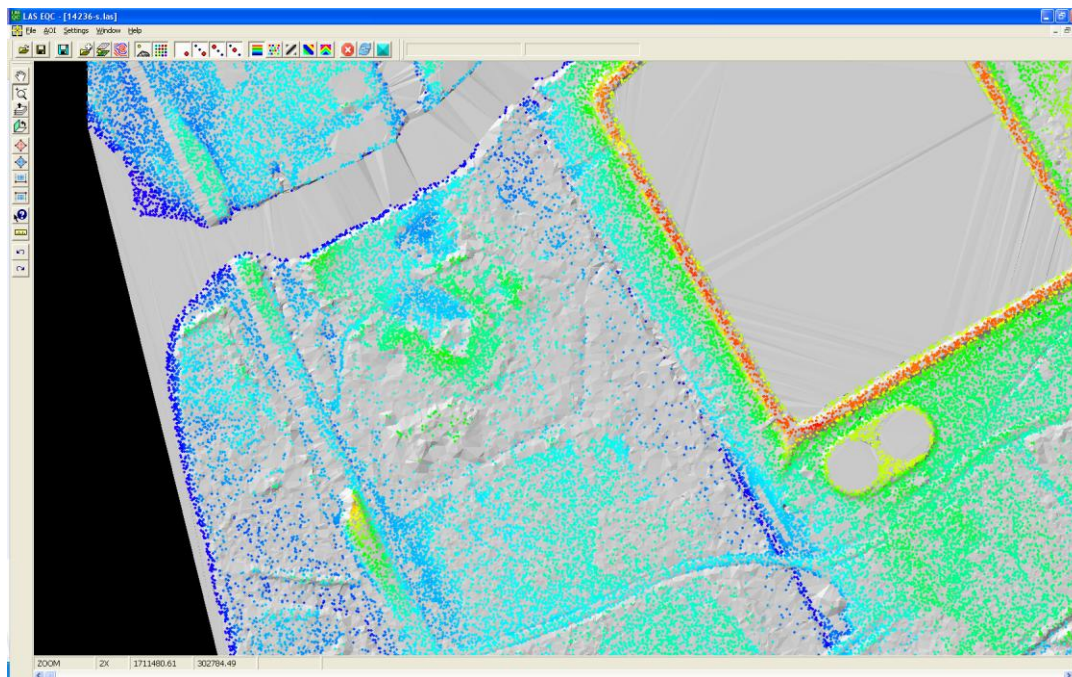
Figure 13: Tile 071993 example of ground points overlaying the TIN. Lidar ground points coverage maintained the berms and roads in the TIN, but density is impacted in heavily vegetated areas.

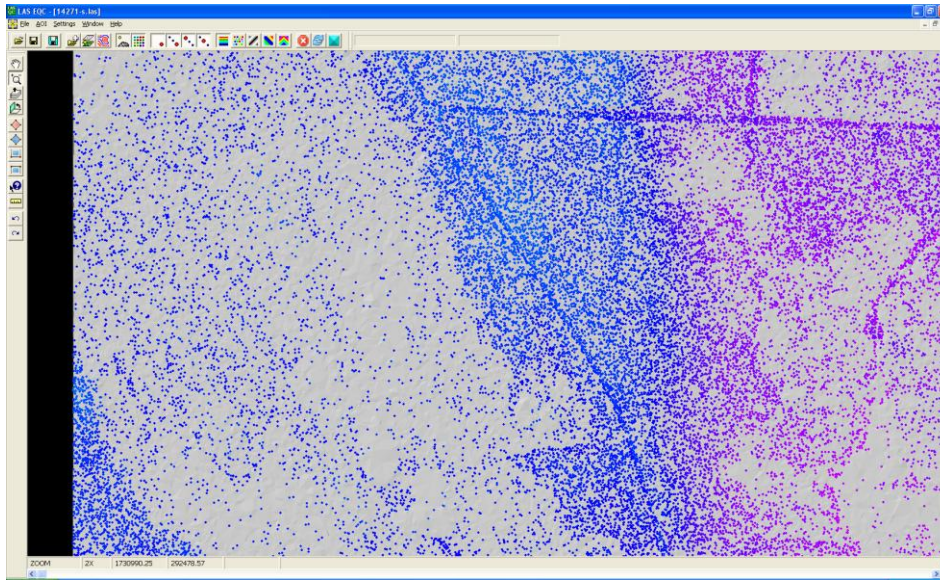
Figure 14: Tile 073077- Ground points overlayed on TIN. Dense vegetation caused ground penetration issues in possible marsh area.

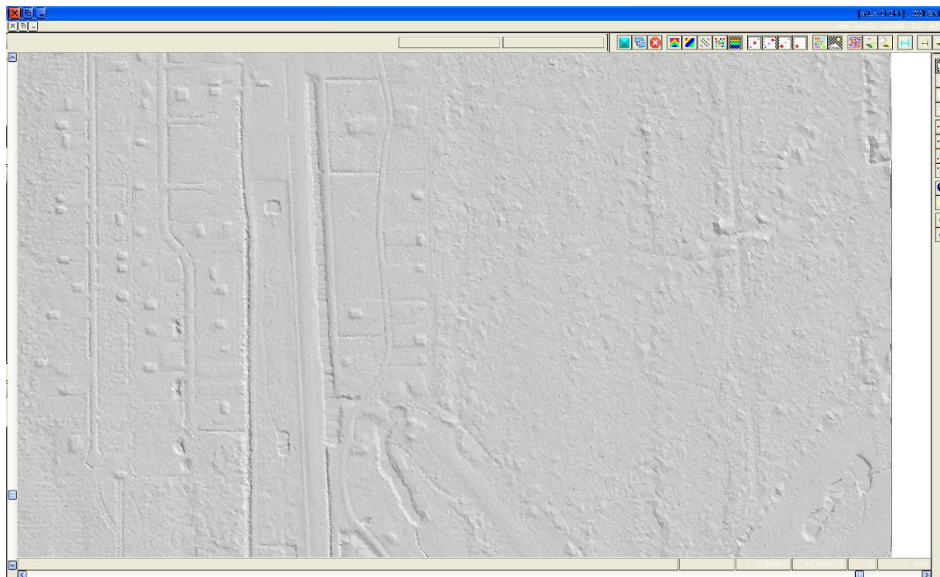
Figure 15: Tile 074694 Tin created from bare earth file. Roads, driveways, etc. are clearly defined. Areas with heavy vegetation are noisy.

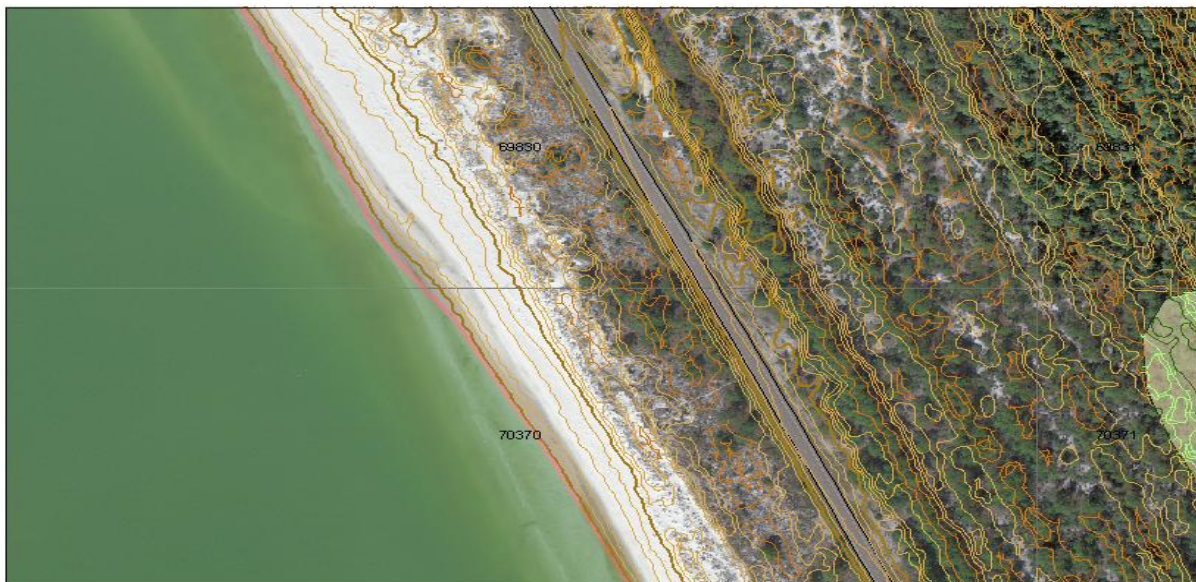
Coastal shorelines are correctly captured as two-dimensional linear features, extracted from the LiDAR data and not from digital orthophotos, except for manmade features with varying heights such as seawalls which are captured as three-dimensional breaklines. Coastal breaklines merge seamlessly with linear hydrographic features. Shorelines continue beneath docks and piers. There is no “stair-stepping” of coastal shorelines. Figure 1 shows example coastal breaklines and contours.

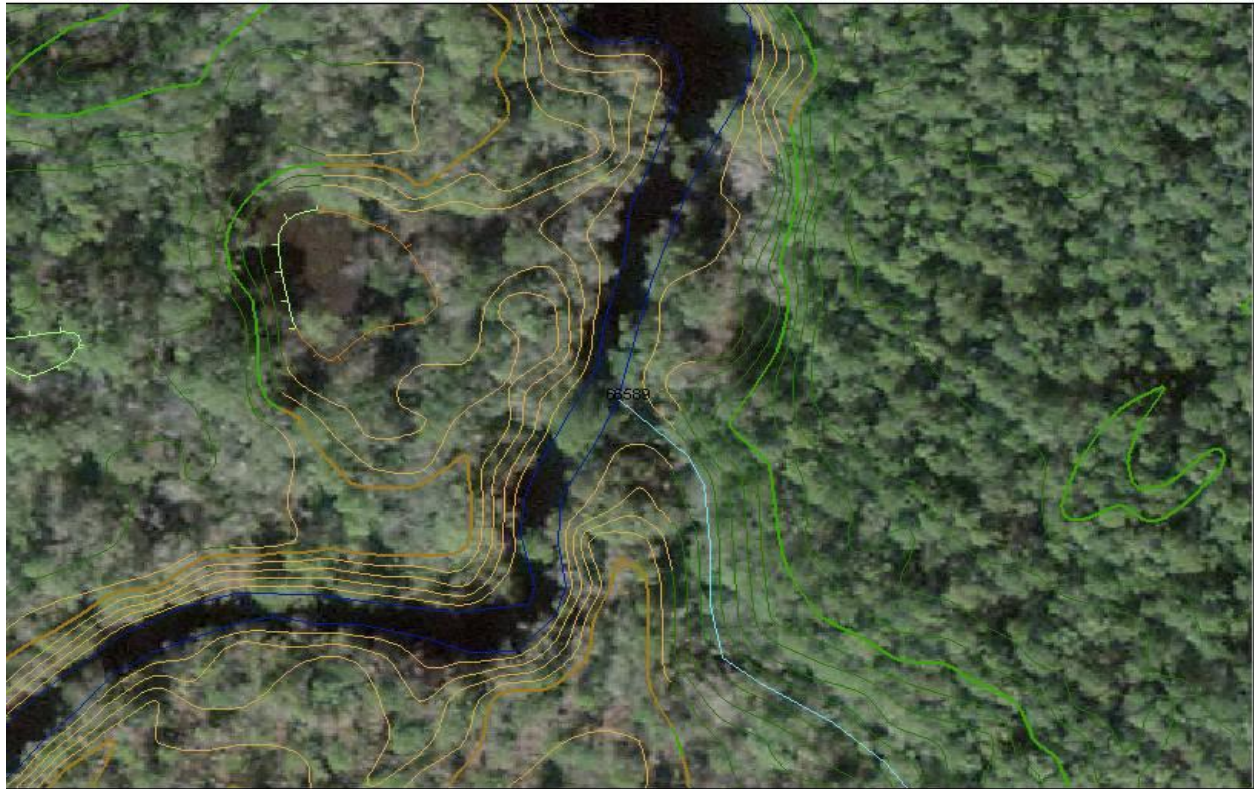
Linear hydrographic features are correctly captured as three-dimensional breaklines – single line features if the average width is 8 feet or less and dual line features if the average width is greater than 8 feet. Each vertex maintains vertical integrity. Figure 2 shows example breaklines and contours of linear hydrographic features.

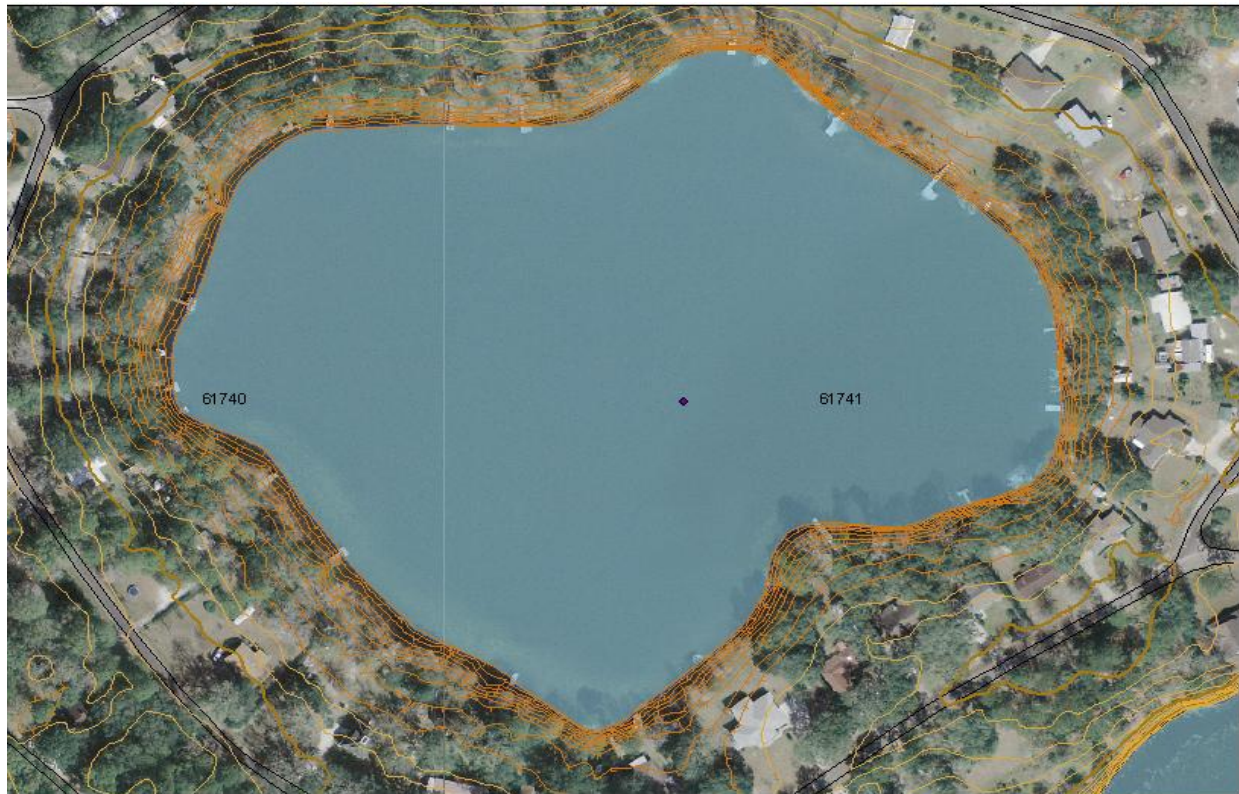
Closed water body features with an area of one-half acre or greater are correctly captured as two-dimensional closed polygons with a constant elevation that reflects the best estimate of the water elevation at the time of data capture. “Donuts” exist where there are islands within a closed water body feature. Figure 3 shows example breaklines and contours of closed water body features.

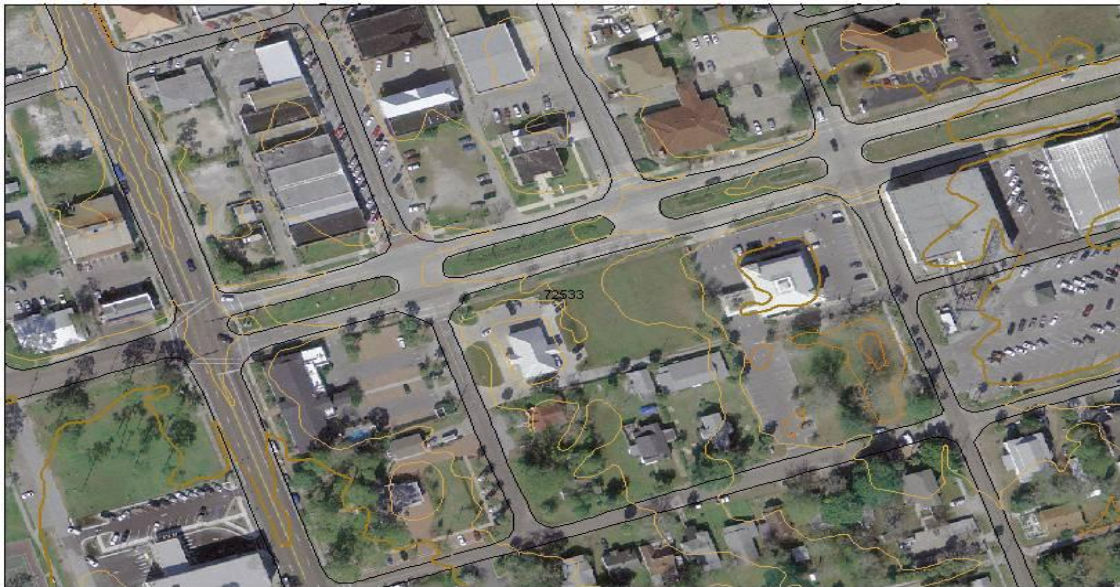
Road edge of pavement features are correctly captured as three-dimensional breaklines on both sides of paved roads. Box culverts are continued as edge of pavement unless a clear guardrail system is in place; in that case, culverts are captured as a bridge or overpass feature. Each vertex maintains vertical integrity. Figure 4 shows example breaklines and contours of road features.

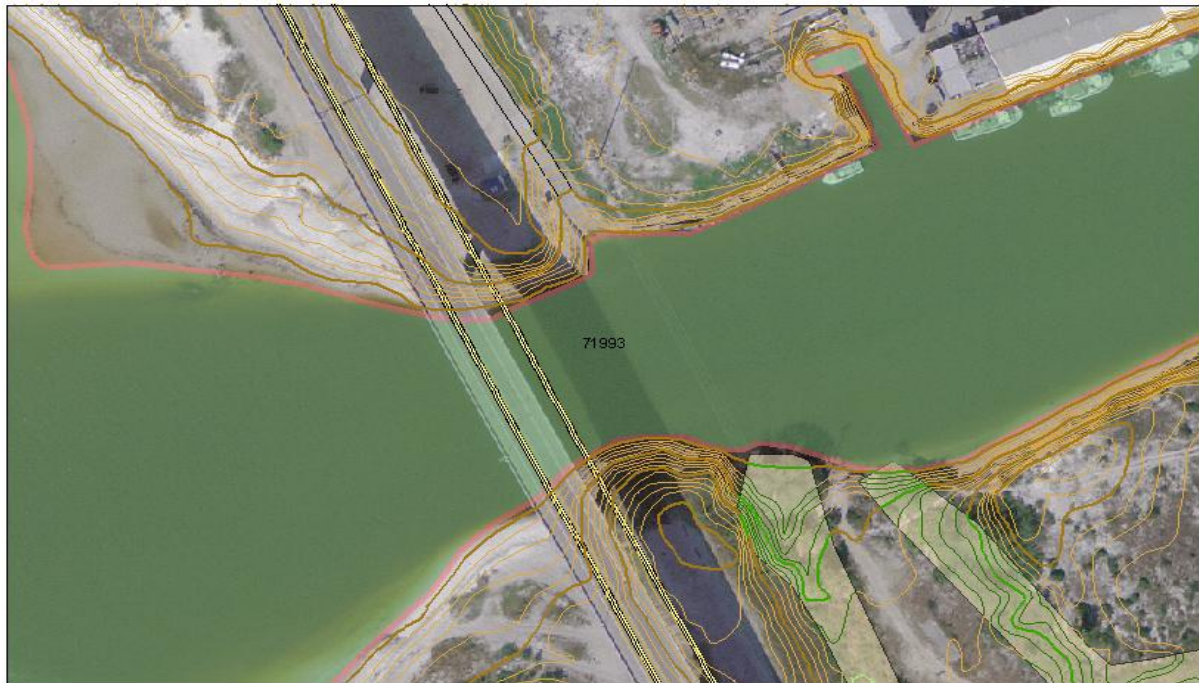
Bridges and overpasses are correctly captured as three-dimensional breaklines, capturing the edge of pavement on the bridge, rather than the elevation of guard rails or other bridge surfaces. Each vertex maintains vertical integrity. Figure 5 shows example breaklines and contours of bridge and overpass features.

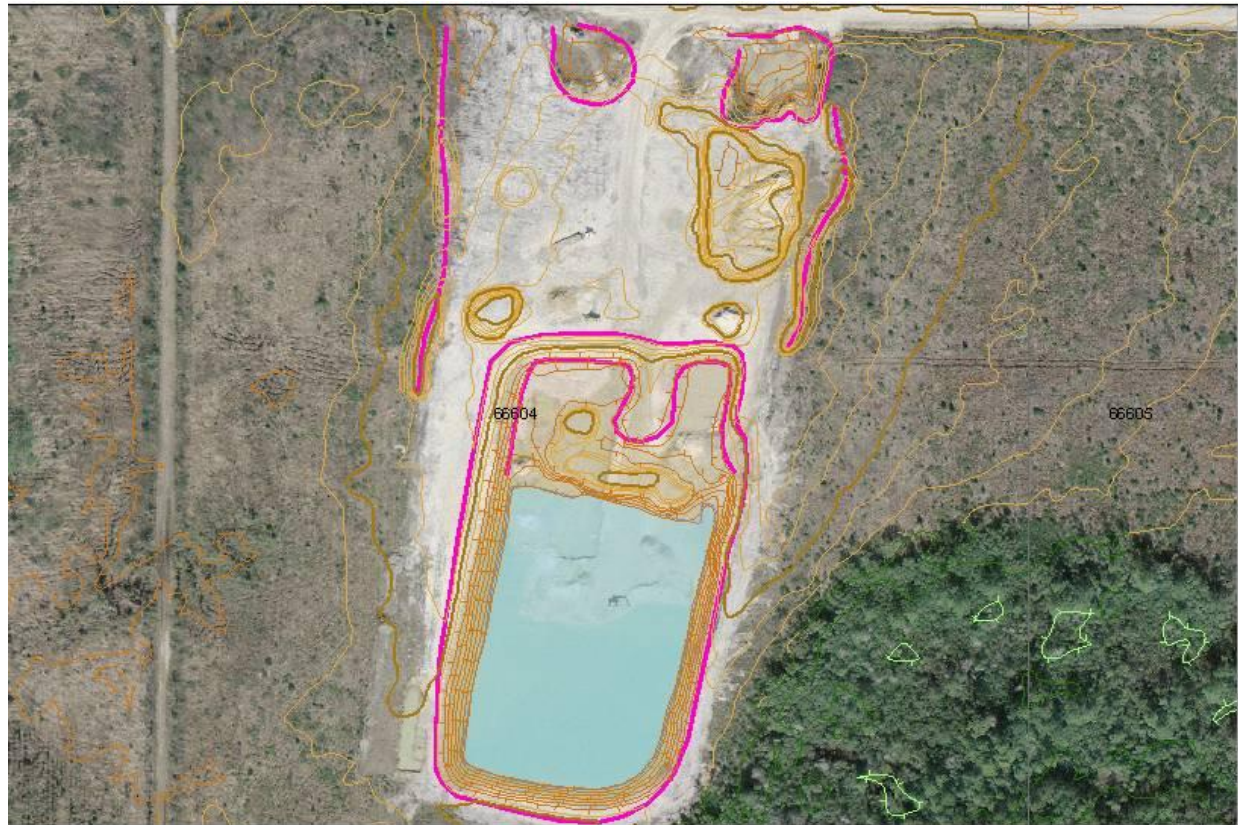
Soft features such as ridges, valleys, top of banks, etc. are correctly captured as three-dimensional breaklines so as to support better hydrological modeling of the LiDAR data and contours. Each vertex maintains vertical integrity. Figure 6 shows example breaklines and contours of soft features.

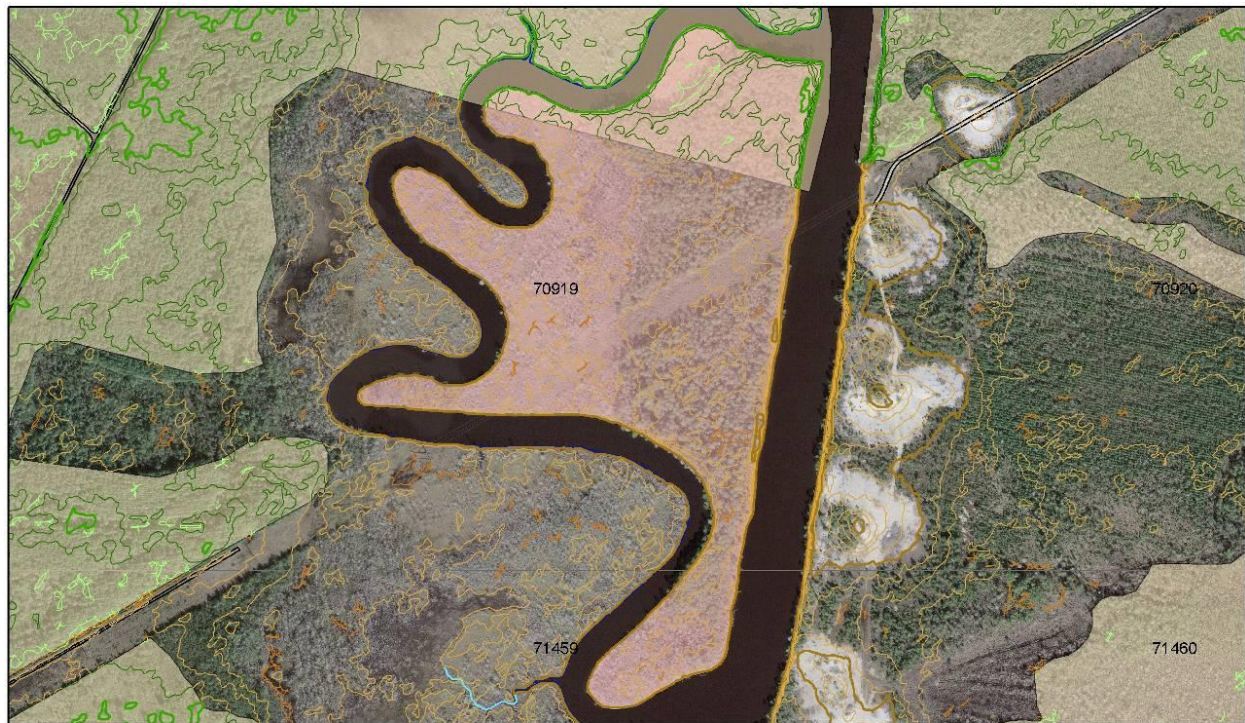
The shoreline of islands within water bodies are correctly captured as two-dimensional breaklines in coastal and/or tidally influenced areas and as three-dimensional breaklines in non-tidally influenced areas for island features one-half acre in size or greater. All natural and man-made islands are depicted as closed polygons with constant elevation. Figure 7 shows example breaklines and contours for island features.
